# Manhole Inspection Summary

Manhole # S35Y1\_020MH

Insp Date: **11/20/07 10:34 AM**

**Location** Address: **33 W Talbott St**

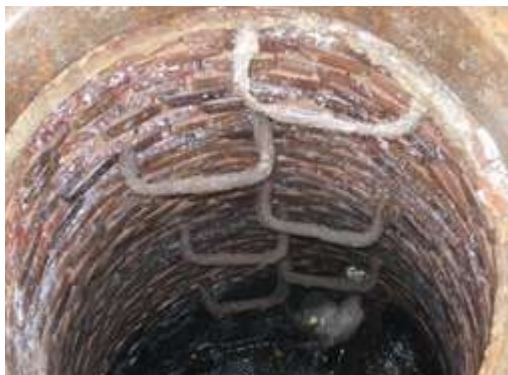
Steps

Count: **9** Missing: **0** ☐ Corroded

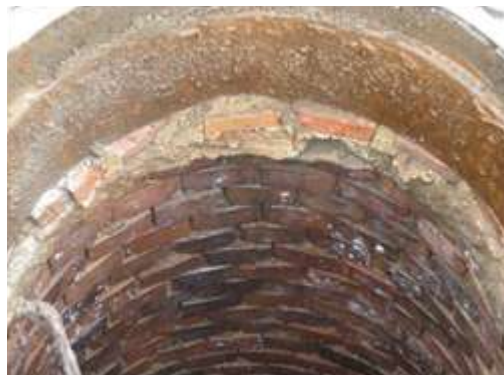
Defect 1

Offset: **2.5** (in.)

Condition: ☐ Sound ☐ Cracked ☐ Root Intrusion ☒ **Loose Brick** ☐ Deteriorated

Infiltration: ☐ None ☐ Joint ☐ Cracks ☒ **Mortar** ☐ Roots ☐ Wall

Frame offset, loose bricks, mortar infiltration

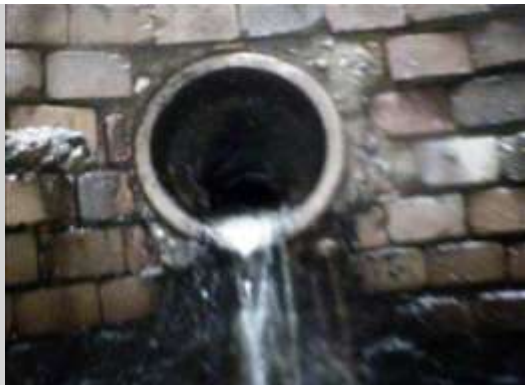
4 O'Clock Inflow

10 in. Circular Gravity Sewer  
Pipe In @ 4 O'Clock

Pipe Height: **10.8** (in.) Rod and Bar (Angled)  
Pipe Material: **Clay** ☐ Pipe Lined  
Invert Depth: **8.16** (ft.) Flow Characteristics: **Fast**  
Deposits: ☒ None ☐ Mud ☐ Sludge ☐ Debris ☐ Grease  
Silt Depth: (in.) Deposits Extent:  
Infiltration: **None** Pipe Seal Cond: **Sound**

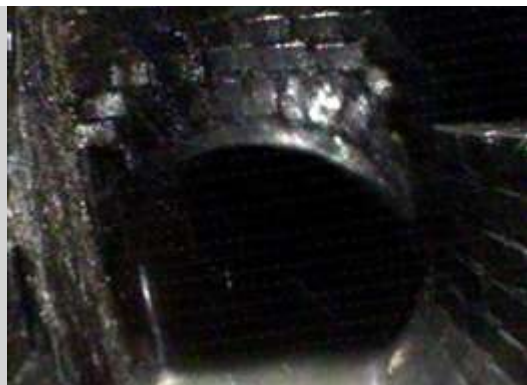
6 O'Clock Inflow

30 in. Circular Gravity Sewer  
Pipe In @ 6 O'Clock

Pipe Height: **28.8** (in.) Rod and Bar (Angled)

Infiltration: **None** Pipe Seal Cond: **Sound**
